FARM MACHINERY INJURY

Injuries associated with posthole diggers

A report for the Rural Industries Research
and Development Corporation

RIRDC Publication No 06/036
RIRDC Project No US-87A

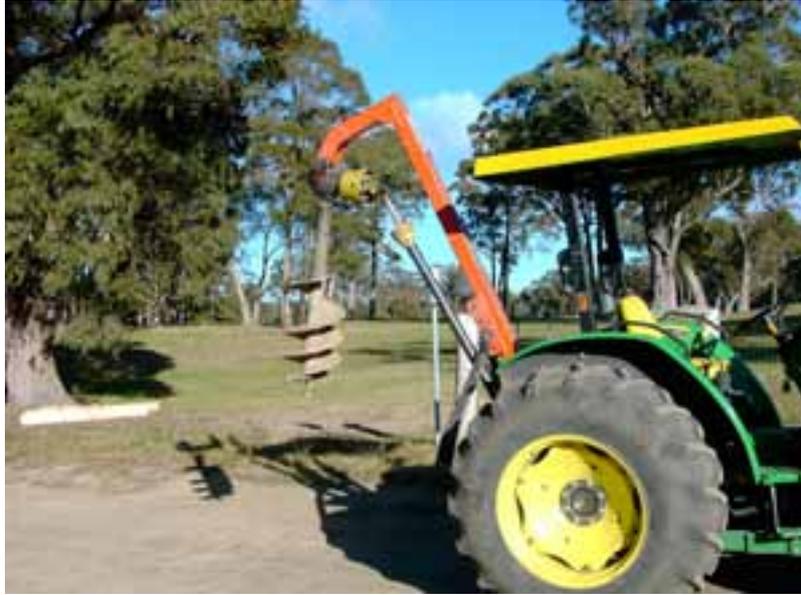
Linkage mounted machines are fixed to the tractor three point linkage arms, and driven by the PTO or a hydraulic motor. The three point linkage may be used to raise and lower the digger, or in some designs the linkage height is fixed, and a separate raising/lowering system is built into the digger.

Linkage mounted posthole digger

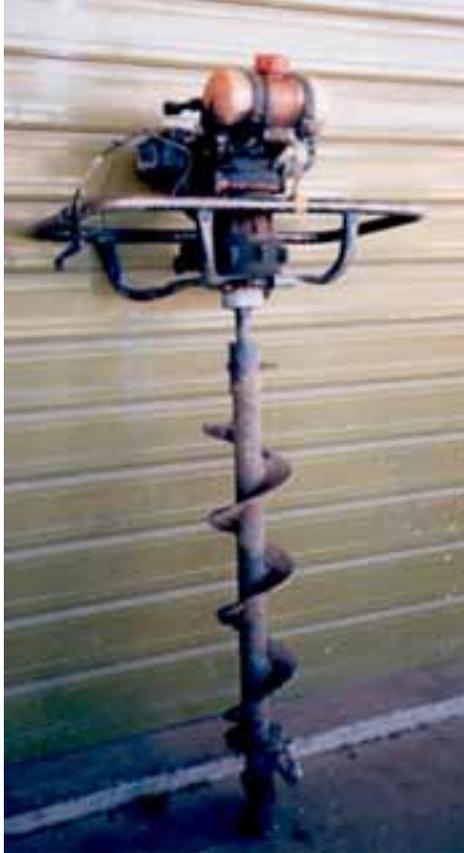
Small, engine driven, augers are manufactured for manual operation, requiring one or two operators. The design consists of a chainsaw type engine mounted on the top of the auger shaft via a reduction gearbox, with handles for the operators.

Portable engine-driven posthole digger

The major hazard with these machines arises when the auger becomes jammed in the hole, and the handles rotate about the auger shaft.

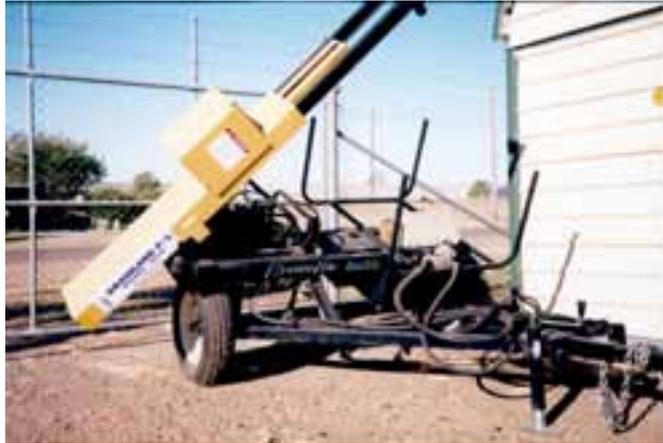
Trailer mounted post driver.

Operation is hydraulic, operating from the tractor remote hydraulic lines.

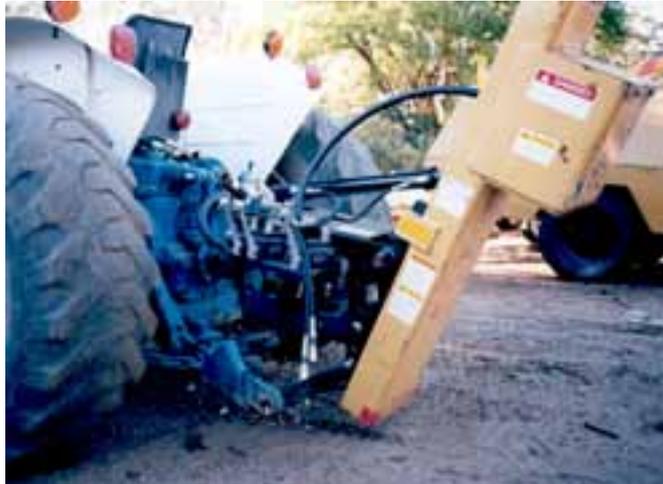
Post drivers consist of a weight (usually 200 to 300 kilograms), which is raised and dropped on the top of the post to drive it into the ground. A small auger for drilling a pilot hole may be fitted.

Three-point-linkage mounted post driver.

The weight is lifted via a wire rope, by use of a hydraulic ram or mechanical winch.

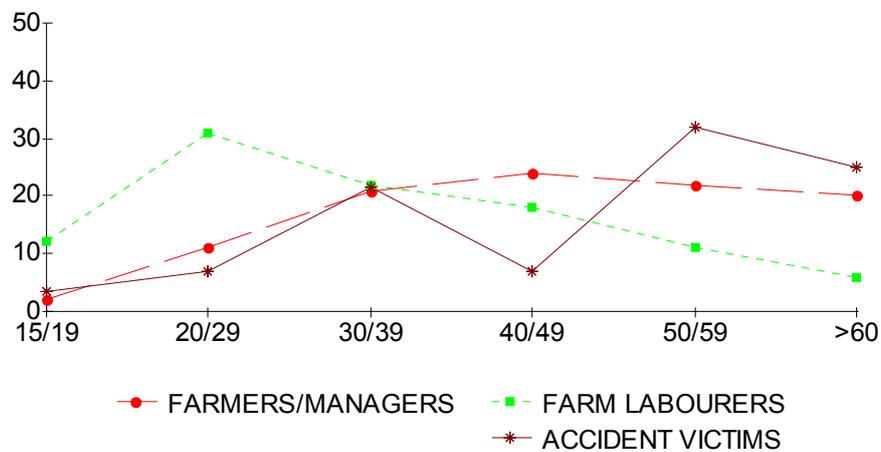
Figure 5.1: Age of posthole digger accident victim compared to age of farm workers

From these cases it would appear that the risk of having an injury may increase for older workers. A study of Table 5.1 in conjunction with Table 5.2 suggests a higher risk that an accident will be fatal for victims over the age of 50 years. If this were the case, possible causes could be postulated:

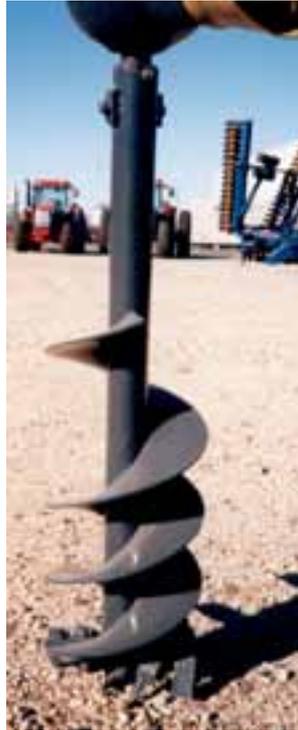
Typical posthole digger auger

The most serious areas of risk with posthole diggers are the PTO shaft and the auger, providing other parts of the machine have the manufacturers guards fitted. Problems with the PTO drive shaft and auger arise from hair or loose clothing becoming caught on the shaft, and pulled in by the rotation. It only requires a small piece of mud or rust adhering to the shaft, or a nick in the shaft, to catch and pull hair or clothing.

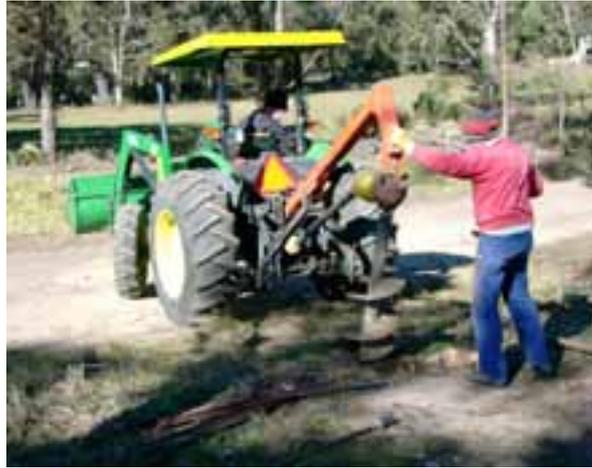
Rocks, tree roots and old steel posts below the ground can cause the auger to jump from the hole and catch the operator, bystanders or wire in the vicinity. Three point linkage digger designs restrain the auger from swinging sideways, but place no restriction on rear swing.

The worker standing behind the digger is in danger of being struck and/or entangled if the auger hits an object and jumps from the hole. Wire, steel posts and tools lying near the posthole increase the hazard.

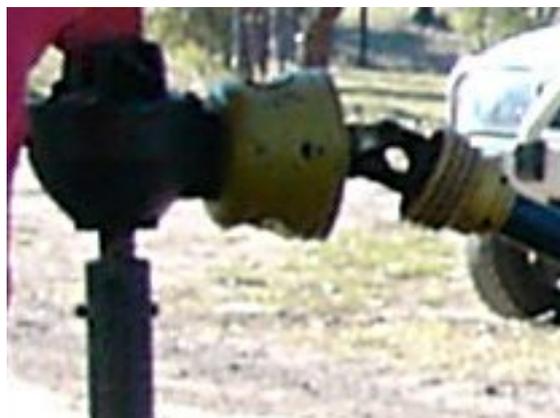
The Australian Standard AS1121-1983, Guards for Agricultural Tractor PTO Drives, provides a guide for the provision of guarding for the power take-off drive, however the specification does not fully protect from entanglement, as hair or a cord may still enter at the end of the drive line, between the tractor or implement shaft guard and the PTO shaft guard. The specification also allows an inverted “U” design for the tractor and implement guards, open at the bottom. There is a possibility of hair or clothing being drawn up under the guard and becoming entangled. It appears that the Standard does not make allowance for wind factors or static electricity that could draw hair etc into the rotating shaft. There remains a risk that operators may become complacent, thinking that an approved PTO guard removes any risk of entanglement.

Power-take-off shaft universal joint exposed when digger is starting to dig.

Two suggested areas for development of improved safety aspects of machine guarding are to utilise more resilient materials for manufacture of the guards, and to simplify the fitting and removal procedures to lower the chance of operators not refitting them following service and repairs.

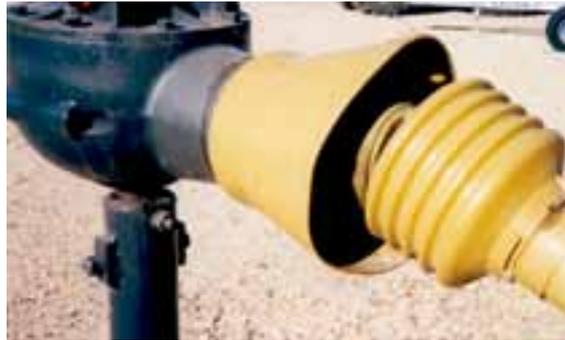
**A different model posthole digger.
The same problem of exposed universal joint is evident.**

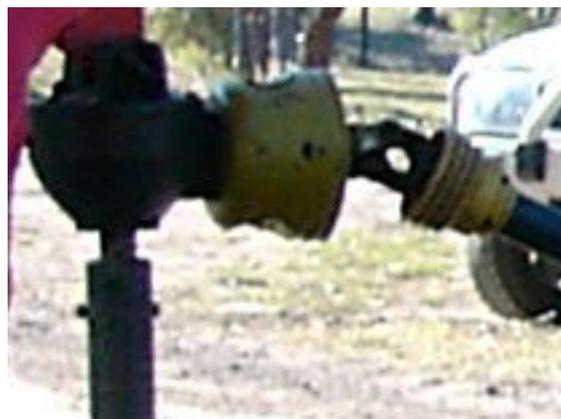
It is considered that for some machine design types it would be possible to fully enclose the PTO shaft through the machine frame. PTO covers currently in use do not fully cover the rotating parts in the area of the universal joints, allowing hair or clothing to become entangled. The PTO shaft should also be guarded in such a way as to prevent it from flailing in the event that a universal joint should fail. Research into improved materials for PTO guards should include testing of static electricity levels generated.

The PTO shaft cover, while apparently complying with the standard, exposes the shaft when the posthole digger is raised.

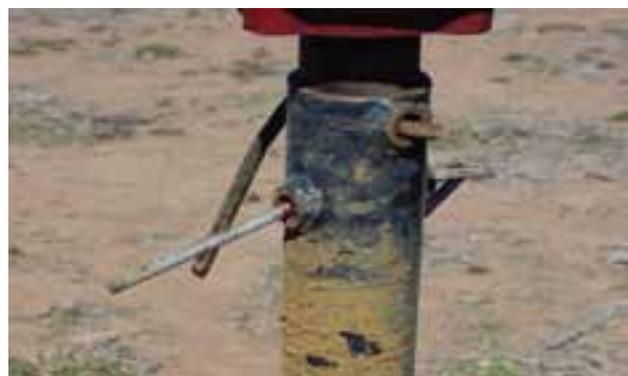
The auger is generally fixed to the auger shaft by means of a shear pin, a metal pin or bolt designed to break, or shear off, in the event of the auger becoming jammed. Shear pins are usually a special bolt, with protruding bolt head and nut. The operator frequently replaces the shear pin with an ordinary bolt, or other metal rod, which may protrude sufficiently to become a catch point for loose clothing etc. The area surrounding the shear pin should be guarded, or the design be such that a non-standard shear pin cannot be used. Original equipment shear pins should be so designed that the ends are flush with the auger tube, with no protruding heads, nuts or fixing pins that could provide a catch point.

Picture showing shear pins replaced with steel rods. The protruding ends make this very dangerous.

Augers and drive shafts should not have any weld slag, notches, balance weights, etc, in a position which could catch clothing or hair. There appears to be a common hazard of weld protrusion or a gap in the joint between sections of the auger flight, which should be addressed during the manufacturing process.

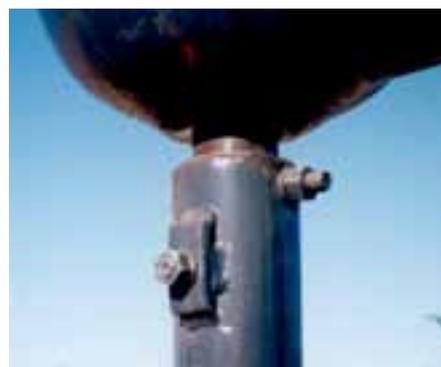
Not as obvious as the previous picture, however these protruding bolts are sufficient to catch clothing.

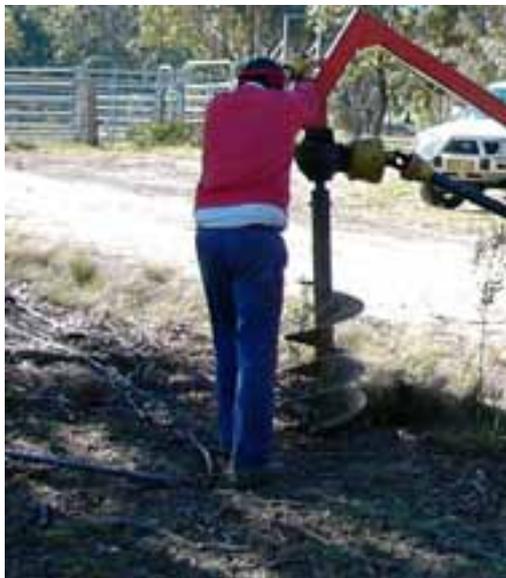
A number of hazards are apparent in this photograph:

- **The workman is pushing on the digger.**
- **The workman is too close to the auger.**
- **The PTO shaft is exposed.**
- **Fence wire is lying adjacent to the hole.**
- **Steel posts are lying adjacent to the hole.**

- Operators must not wear loose clothing, or clothing having a drawstring.
- No person, worker or bystander, should be allowed to approach the machine while it is in operation.

- Remove all fence wire, wire netting, etc, a minimum of five metres from the vicinity of the posthole.
- The correct cutter points to suit digging conditions must be used and maintained in good condition.

- Manufacturers' safety guards must be fitted to the machine.
- The posthole digger must be serviced and repaired to maintain optimum operating ability.
