6 FEBRUARY 2019

Sydney University Construction Environment Audits

Susan Wakil Health Building Construction Independent
Environment Audit 1

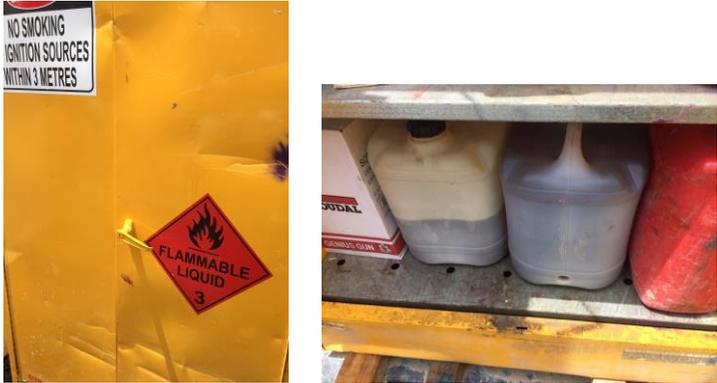
<p>Storage and Handling of Dangerous Goods and General Housekeeping</p>

<p>Photos show BKH Chemical storage unlabelled chemical containers (identified as Release Agent to stop concrete sticking), DG 2 aerosols stored with DG 3 flammables – Non-compliant storage.</p> <p>Non-Conformance with CEMP, pg 20, Section 16.8 Handling, Storage, Packaging, Transport. Recommendation that LoR separate DGs from combustibles, label all chemical containers, train all staff and contractors in the storage and handling of Dangerous Goods.</p> <p>General housekeeping could be improved on site with the removal of empty boxes and debris from construction material delivery strewn across the site.</p>

No.	Category	Action	Responsibility	Timing	Status
Susan Wakil Health Building Stage 1					
1.	Non-Conformance	Non-Conformance with CEMP, pg 20, Section 16.8 Handling, Storage, Packaging, Transport. Recommendation that LoR separate DGs from combustibles, label all chemical containers, train all staff and contractors in the storage and handling of Dangerous Goods and hazardous substances.	Laing O'Rourke	Immediate	Closed following audit response from LoR on 1/2/19 (see Appendix A)

No.	Category	Action	Timing	Status
1	Non-conformance	<p>Dangerous Goods to be separated from combustibles, with all chemical containers labelled.</p> <p>Train all staff and contractors in the storage and handling of Dangerous Goods.</p>	Immediate	<p>All hazardous substances previously found in Brefni container have now been removed from the site. The container is only to be used for storage of tools and will be removed from site completely within the next few weeks.</p> <p>New slides to be included in induction. All LOR site staff will be trained in these procedures.</p> <p style="text-align: center;">

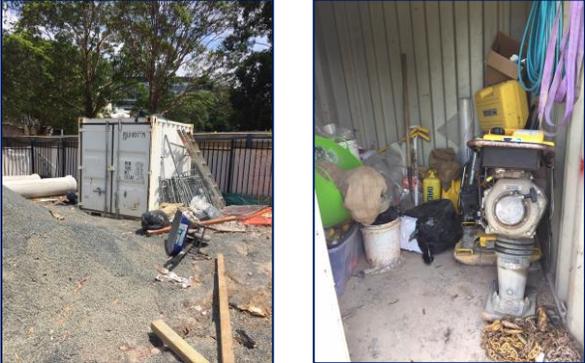
<p>Photos on the left show a white unlabelled Brefni storage container, storing fuels with combustibles – Non-compliant storage and DG signage.</p>
<p>Hazardous Material (ACM) Management/Unexpected Finds</p>

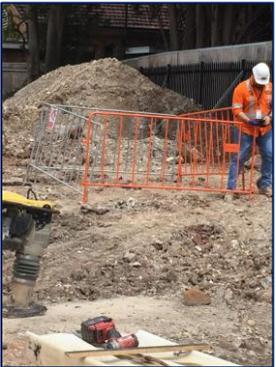
<p>During the audit inspection a suspected unexpected asbestos find was identified by the audit team. LoR immediately isolated the area and notified all staff working on site. LoR advised post audit that ADE Consulting Group was engaged and provided a Visual Clearance Certificate on 19/12/18 (identified the sample as bonded asbestos containing material ACM) and a disposal docket was provided from Suez Recycling and Recovery Pty Ltd on 20/12/18 for a chargeable weight of 0.50t.</p> <p>Recommendation as above to train all staff and contractors in hazardous materials unexpected finds.</p>
<p>Evidence of CEMP implementation - Dust Suppression</p>

2.	Opportunity for improvement	It is recommended that LoR train staff and contractors in spill response procedure and asbestos unexpected finds, evidence of training to be provided by LoR.	Laing O'Rourke	Immediate	Closed following audit response from LoR on 1/2/19 (see Appendix A). Unexpected finds training occurred on 22/1/19.

2	Room for improvement	Train all staff and contractors in hazardous materials and unexpected finds (Asbestos find).	Immediate	Unexpected finds training included in monthly enviro awareness training held on 22 nd Jan. All LOR site staff now trained.

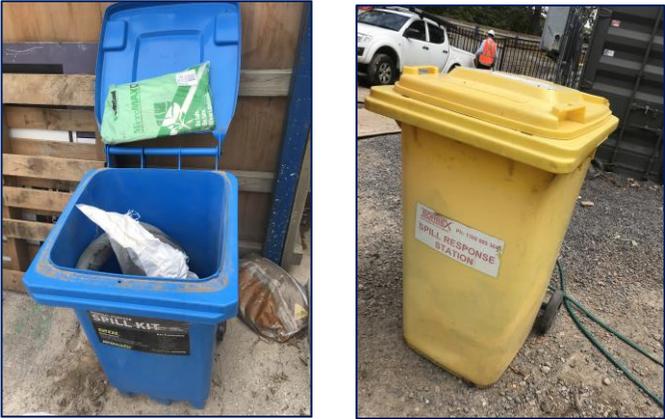
Audit scope	Comment
<p>Evidence of CEMP implementation - Spill Kits</p>

<p>Two general purpose spill kits were observed on site. Spill kits had some litter inside and weren't placed directly near the chemical storage containers below.</p> <p>Recommend spill kit lids be secured with cable ties to avoid littering and placed closer to chemical storage areas.</p> <p>Toolbox Talk register to be provided by LoR. Induction presentation was provided to the audit team (two WHS toolbox talks were provided for Heat Stroke and Nurse Call). It is recommended that ALL LoR staff and contractors are trained in the Environment Incident Procedure and Spill Response, in accordance with Conditions A20, A21, A22. It is recommended that Environment Incident, Spill Response and Chemicals/Dangerous Goods storage are included in the project Induction presentation.</p>
<p>Evidence of incident management reporting (i.e. incident register and follow up actions).</p>	<p>The Hazchem Spill Kit was sighted in the vicinity of the Dangerous goods storage container. It is recommended that LoR train staff and contractors in spill response procedure and asbestos unexpected finds, evidence of training to be provided by LoR.</p> <p>LoR advised no environmental incidents occurred from construction commencement September – December 2018. RPS requested a copy of the incidents and complaints reporting templates, this was provided by LoR on 9/1/18.</p>

6.	Opportunity for improvement	Recommend training in spill response. Recommend spill kit lids be secured with cable ties to avoid littering and placed closer to chemical storage areas.	Laing O'Rourke	Within two weeks of issuing the final audit report	Closed – LoR advised all spill kits are now secured with cable ties (see Appendix A). New slides have been added to induction regarding environment incident reporting and spill response.

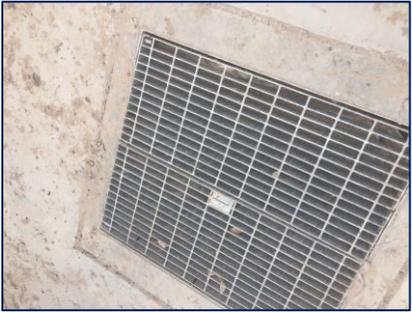
<p>Evidence of implementation of the CEMP and sub plans (i.e. erosion and sediment control plans, waste/materials tracking register/waste docket, noise and vibration monitoring records, out of hours works approvals, asbestos checklist).</p>

<p>The CEMP was provided with all sub-plans present.</p> <p>Complaints Register</p> <p>LoR provided the Complaints Register for future complaints. LoR and a Sydney University representative advised no complaints were received to date.</p> <p>Water Quality Testing and Discharge</p> <p>LoR advised no dewatering has been undertaken to date, this may need to occur for high intensity rainfall. LoR to provide water quality testing and discharge testing procedure. Also advise the frequency of stormwater drains geofabric clean out (noting a frequency of 2-3 weeks is inadequate) in accordance with CEMP section 16.12 and 16.3, recommend a greater frequency of clearing of stormwater drains.</p> <p>Waste Disposal and Materials tracking register</p>

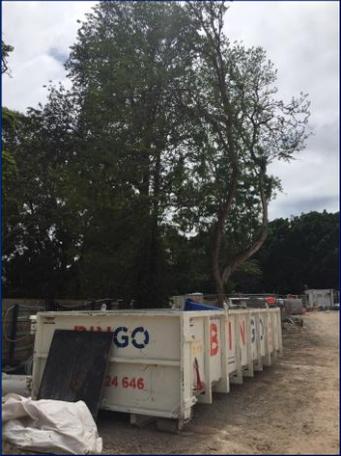
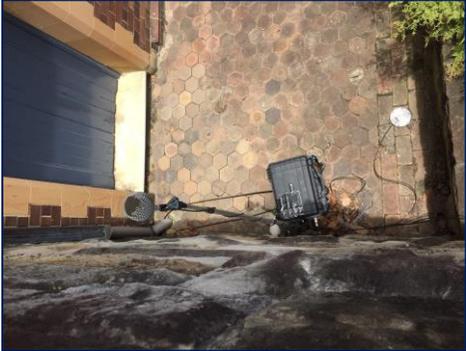
<p>Waste disposal on site is comingled, LoR advised all waste was sorted by Bingo waste, suggest LoR request Bingo waste receptacles with lockable covers to avoid overspill/dumping.</p> <p>The waste tracking register was available on site, provided to RPS.</p> <p>Out of Hours Works Community Notification for removal of piling rig out of hours dated 30 October 2018 was provided. The piling rig was removed from site from 10pm on Wednesday 31 October 2018. Noise monitoring for Out of Hours Works on 30 October 2018 to be provided by LoR.</p> <p>Noise monitoring equipment was observed during the audit in the vicinity of Wesley College opposite the construction site, as per the NVMP.</p> <p>Resonate Noise and Vibration Monitoring Report dated 26 September – 24 November 2018, S180787RP1 Revision 0 was provided by LoR. The report summarises the results of the noise and vibration monitoring conducted by EHO Consulting and considers the results against the requirements of the CNVMP.</p> <p>Throughout the monitoring period at RPAH, measured noise levels exceeded the NML of 70 dB(A) Leq,15min for a total of 11 occasions during working hours throughout the entire monitoring period. It is noted that some of these occurrences may be the result of extraneous events as a number of exceedances of the NML occurred outside of working hours.</p> <p>Given the relatively small number of isolated exceedances that occurred throughout the entire monitoring period, it is not considered that noise levels from the construction works are significantly impacting on RPAH. However, reasonable and feasible noise mitigation measures should be implemented on site as per the approved CNVMP (Resonate CNVMP M17183RP4, Rev C, dated 12/9/18, Section 6).</p> <p>It is noted that while significant data was available at both RPAH and Bosch 1B across the monitoring period, 1-2 weeks of data was not available at each location. Data was also unavailable for extended periods at Wesley College but it is noted that continuous monitoring was not required at this location under the CNVMP.</p> <p>Vibration alert trigger levels for RPAH and Bosch 1B were set at 4 mm/s PPV and 2 mm/s PPV respectively, whereas more stringent trigger levels were required in the CNVMP. This was identified as a non-conformance and would mean that some vibration alerts would have been missed.</p>

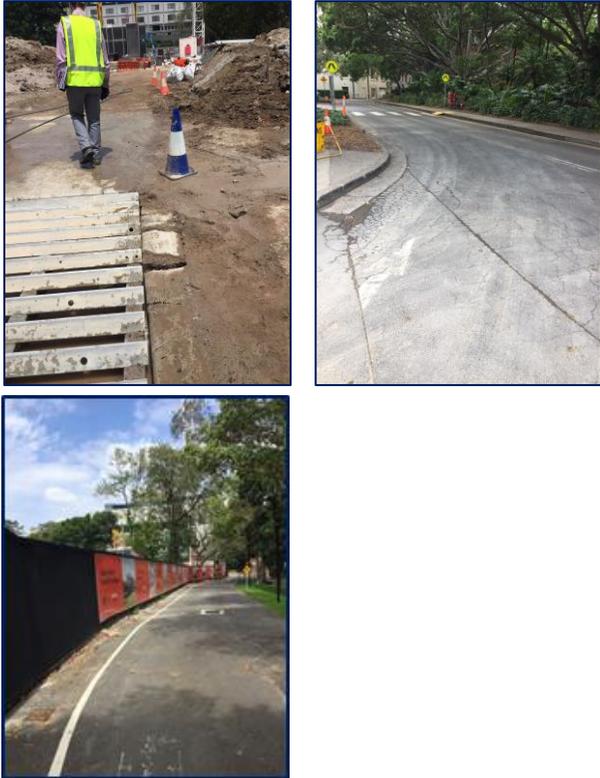
<p>Further vibration monitoring results to be provided; as works continue, reasonable and feasible noise and vibration mitigation measures should be implemented on site as per the CNVMP.</p> <p>However, it is noted that the works generally complied with the vibration management levels specified in the CNVMP.</p> <p>Suggest preparation of a separate stand-alone ERSED Map that can be updated easily and is accordance with condition B9 and as per CEMP Appendix 5 listing key ERSED control measures. Site stockpiles are to be stabilised.</p> <p>Mud tracking is to be monitored by LoR with stabilisation of the additional area/soil between the site and road to be considered. A road sweeper is suggested post commissioning, prior to Practical Completion.</p> <p>No water cart on site was observed for dust suppression, however hoses for dust suppression were observed.</p> <p>RPS suggested that LoR reinstate sandbags, or salvage coir logs (that were compromised) to act as energy dissipaters to reduce the flow of dirty water offsite down the road through the site hoarding. Historical white residue seepage from site was observed staining the pedestrian footpath adjacent to the oval. This could not be explained by LoR.</p> <p>LoR to reinstall compromised sand bags along the site perimeter and make sure the external site perimeter is monitored for any compromise of ERSED control as part of the environment inspections. It was noted that ERSED fencing was installed around the internal perimeter well.</p> <p>It was noted that the site had appropriate hoarding and signage, the Principal Contractor Laing O'Rourke Australia, Site Manager Jason Turnbull with Site Contact mobile number: 0448 492 644 was displayed on the gate.</p>

No.	Category	Action	Responsibility	Timing	Status
4.	Opportunity for improvement	Vibration alert trigger levels for RPAH and Bosch 1B were set at 4 mm/s PPV and 2 mm/s PPV respectively, whereas more stringent trigger levels were required in the CNVMP. Further vibration monitoring results to be provided; as works continue, reasonable and feasible noise and vibration mitigation measures should be implemented on site as per the CNVMP (Resonate CNVMP M17183RP4, Rev C, dated 12/9/18, Section 6).	Laing O'Rourke	Within one month of issuing the final audit report	Ongoing to be confirmed in Audit 2. LoR response provided, Excel Noise and Vibration Data dated 3/11/18

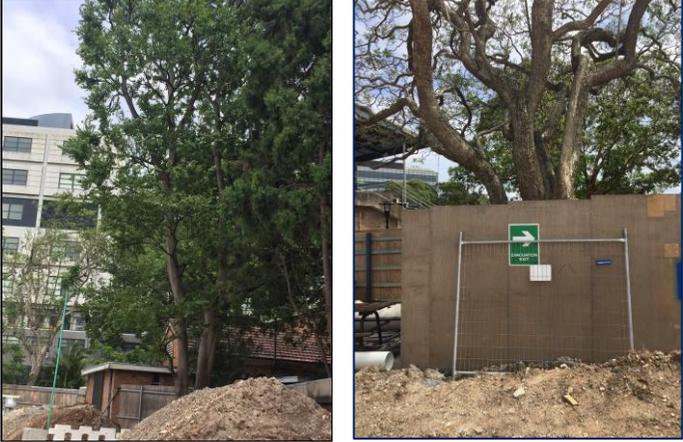
<p data-bbox="956 245 1980 528">The Tree Protection Certification was provided to RPS on 9/1/19, prepared for Laing O'Rourke in relation to the Susan Wakil Health Building. A site inspection was undertaken by Martin Peacock (treeiQ) and Christopher Stone (Laing O'Rourke) on the 23rd October to review the tree protection measures as required by Condition C17 Tree Protection. A number of hold points were placed on certain trees in the treeiQ report dated 25 October 2018. LoR to provide evidence of toolbox talks to construction staff and contractors regarding these tree protection zones hold points. It is noted that the Vegetation hold point has been included in the Environment Control Map provided. It is recommended that document control (date and version) be placed on the Environment Control Map/ESCP.</p>

12.	Opportunity for improvement	LoR to provide evidence of toolbox talks to construction staff and contractors regarding these tree protection zones hold points.	Laing O'Rourke	Within two weeks of issuing the final audit report	Closed – evidence provided and presented on 1/2/19. Ongoing in Induction to be confirmed in Audit 2.

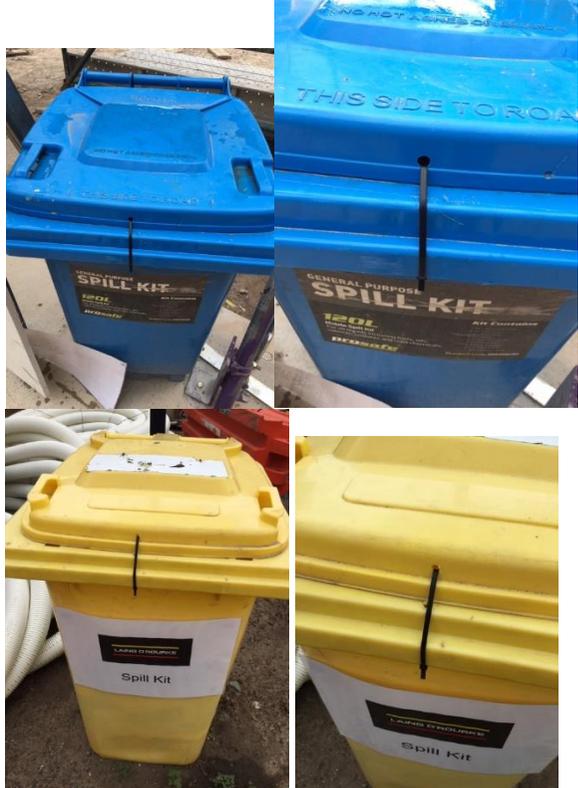
<p style="text-align: center;">Dust and air quality MANAGEMENT</p> <ul style="list-style-type: none"> ❖ Prevent /minimise dust & air emissions from site: ❖ Cover stockpiles/exposed surfaces causing or with potential to generate dust ❖ Ensure dust mitigation measures are implemented e.g covering stockpiles with geofab/plastic tarps, use of water carts/ hoses ❖ Maintain equipment to prevent smoky exhausts ❖ All loads to be covered and tailgates fixed securely prior to leaving site (to prevent spillage or escape of dust, waste, spoil) ❖ In high wind conditions – Site Manager to assess and stop works until adverse conditions subside / implement any additional controls <p style="text-align: right;"><small>14</small></p>
6	Room for improvement	<p>All staff and contractors be trained in Spill Response procedures.</p> <p>Spill kit lids to be secured with cable ties to avoid littering and placed closer to chemical storage areas.</p>		<p>All spill kits on site have now been secured shut and are located close to chemical storage areas.</p>

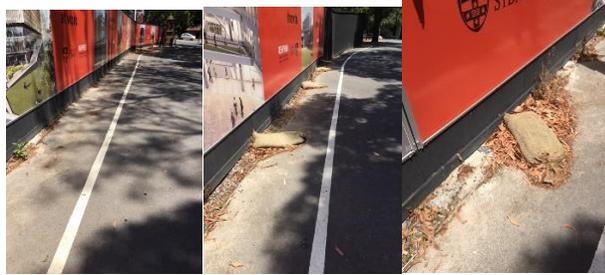
10	Room for improvement	<p>Reinstall compromised sand bags along site perimeter and make sure external site perimeter is monitored for any compromise of ERSED controls.</p> <p>Monitoring of external site perimeter for any compromise of ERSED controls to be</p>	Within 2 weeks of issuing the final report

<p>This will be added to E-T-8-1227 Environmental Inspection Report for use in Fieldview.</p>

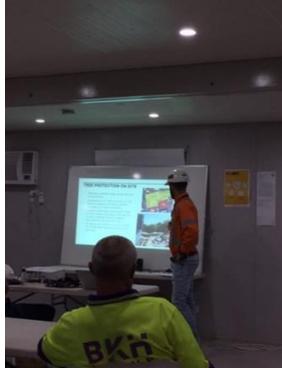
<p>OPERATIONAL CONTROLS</p> <ol style="list-style-type: none"> HOLD POINT: No clearing or removal of vegetation is permitted without appropriate approval. All vegetation to be retained must be protected with hoarding, fencing, tape etc. This is to be maintained for the duration of works. Construction work is only to be carried out in designated areas. When trees are to be removed, an appropriately qualified tree removal contractor must be used. Plant, equipment and materials are not to be stored within the dripline of any trees or vegetation or within establishment of tree protection zones. Be wary of root structures when carrying out any trenching or excavation works adjacent to trees. Stop work if tree roots are encountered.

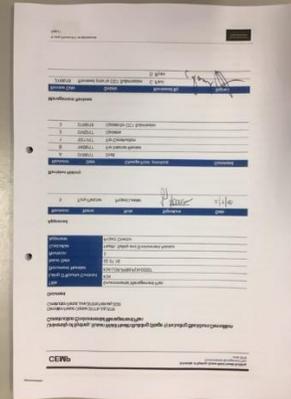
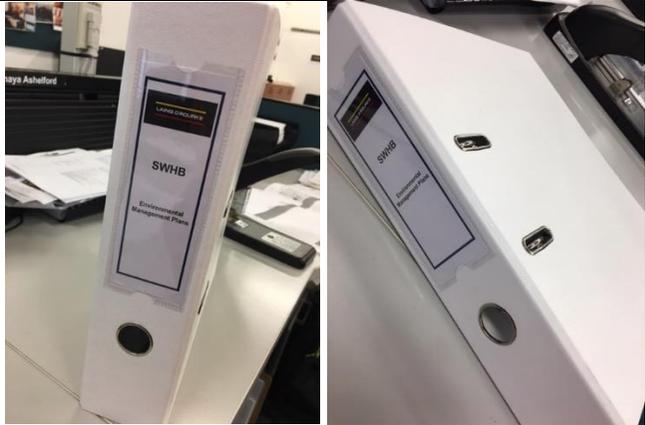
13	Room for improvement	All documents be displayed in hard copy on site for reference by the construction team and subcontractors BKH and Brefni. (Project Approval, CEMP including sub-plans, Complaints and Waste Registers, other permits and licences, Environmental policies, Environmental Constraints Map, Incident Reporting Flow Chart)	Within 2 weeks of issuing the final audit report	Hard copies of CEMP including sub-plans (CNVMP, CWMP, CTPMP, ACHMP) are now available on site. <div style="display: flex; flex-wrap: wrap; justify-content: space-around;">

<p>The Environmental Constraints Map is included in Appendix 5 of the CEMP. The Incident Reporting Flow Chart is included in Appendix 1 of the CEMP. Environmental policies are accessible to everyone online through Next Gear public website. https://nextgearsms.com/ Project approval, other permits and licences are all available as hard copies on site. Complaints and waste registers will be maintained electronically only due to the frequency at which they have the potential to be updated</p>
--	--	--	--

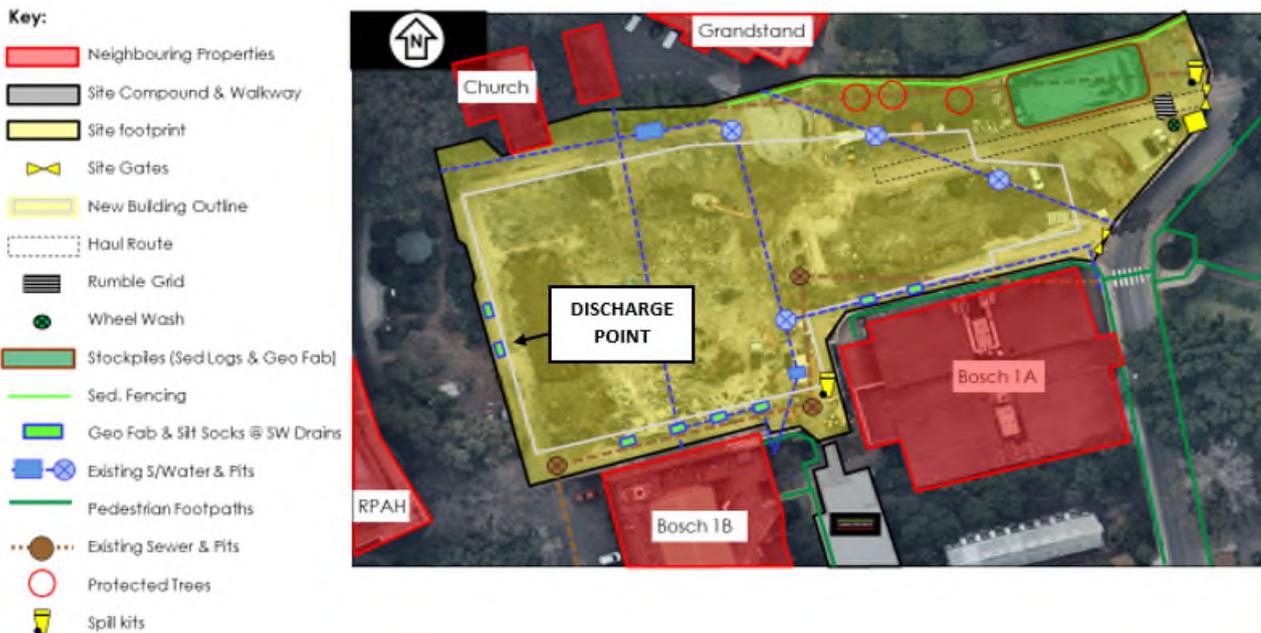
Figure 1. Environmental control map with water discharge point.

- Water will be pumped into a lined bin.
- Gypsum will be added to the water at a rate of 40kg/100m³ and left over night.
- Water will be tested using a TSS Meter to determine that turbidity is below or equal to 50mg/L.
- Water will be tested using a digital pH meter to ensure pH is between 6.5 and 8.5.
- If the results comply with water quality standards, water will then be discharged into the nominated point. The nominated discharge point is a storm water drain at the western boundary of the site shown in Figure 1.
- Sediment left at the bottom of the bin will be discarded into general waste.
- If test does not comply, further treatment will be required and the process repeats until the water is suitable to discharge.
- A 2" Flex Drive pump will be used to pump the water, which has a maximum pump rate of 25,000L/hr.
